Exploring the potential of Raman spectroscopy for the identification of silicone oil residue and wear scar characterization for the assessment of tribofilm functionality

Keywords: Raman spectroscopy,  
Cross-sectional TEM,  
Silicone oil residue,  
Tribofilm

# Exploring the potential of Raman Spectroscopy for the identification of silicone oil residue and wear scar characterization for the assessment of tribofilm functionality

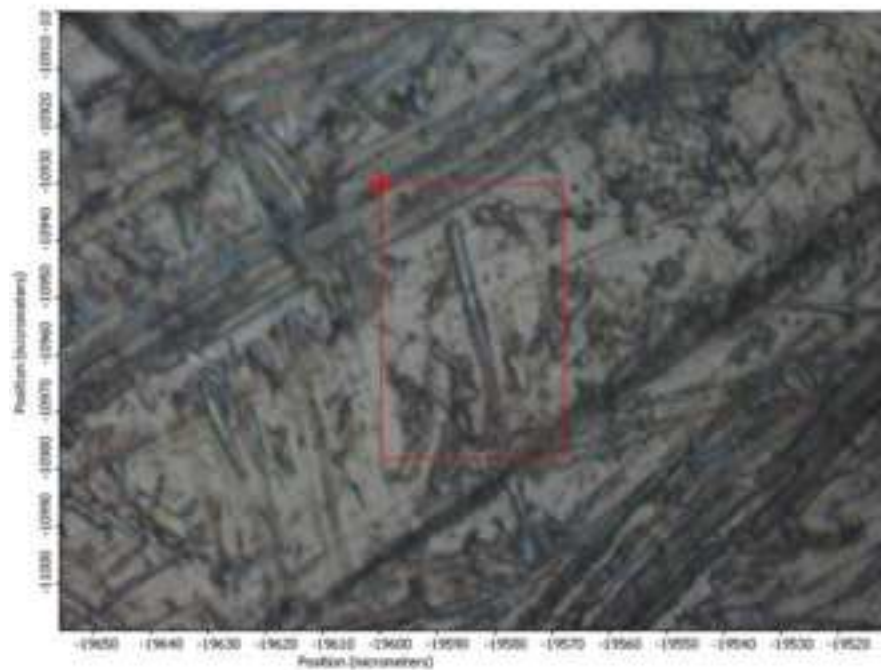
It should be mentioned that the intensity of the main silicone fingerprint is not uniformly distributed over the whole disc surface. Raman mapping can depict this. Fig.3 shows two examples of optical micrographs and their respective Raman maps produced by using

intensities obtained from windows around the major peak at  $2900\text{ cm}^{-1}$ . Partly, the sites of higher silicone intensity correspond to features of the optical micrograph (e.g. groove-like features or roughness troughs, but this is not always the case. The dark blue areas of the Raman maps, visible in the web version of the article (major part of the maps, except bright spots with dark cores in the printed version) correspond to Raman spectra like the one shown in Fig.2c. Here definitely all silicone oil residues have been removed.

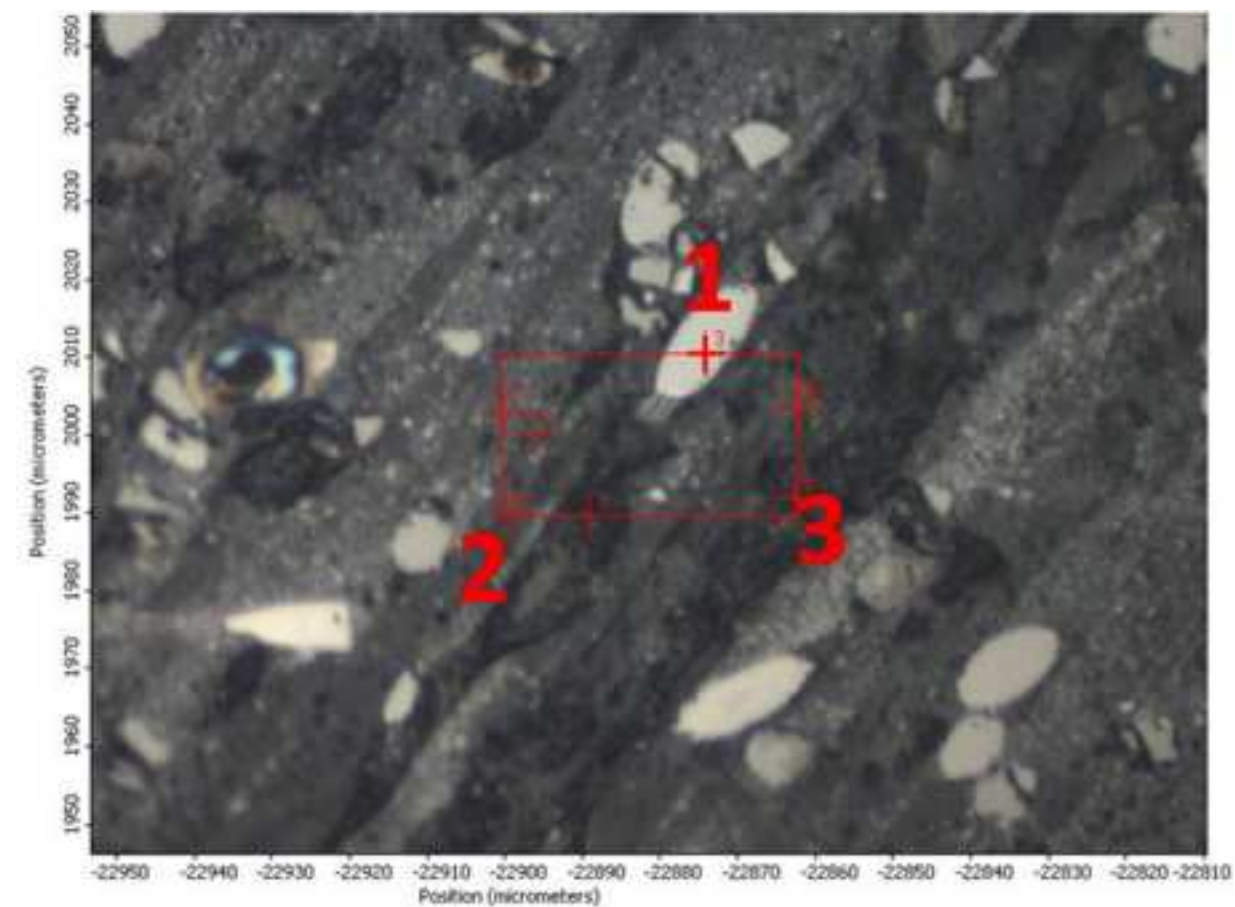
Fig.5 site 1 shows a typical spectrum of a carbon fibre. It shows only two major peaks, the D band at approximately  $1350\text{ cm}^{-1}$  for disordered carbon, and the G band at  $1580\text{ cm}^{-1}$  for graphitized carbon, in accordance with results from literature [29].

- Fig.4 Comparison of RS within and outside of a wear scar of the steel disc
- Fig.5 Raman spectra acquired from the surface of a rubbed composite pin comprising of epoxy mixed with 10 vol.% carbon fibers and 2 vol.% silica nanoparticles

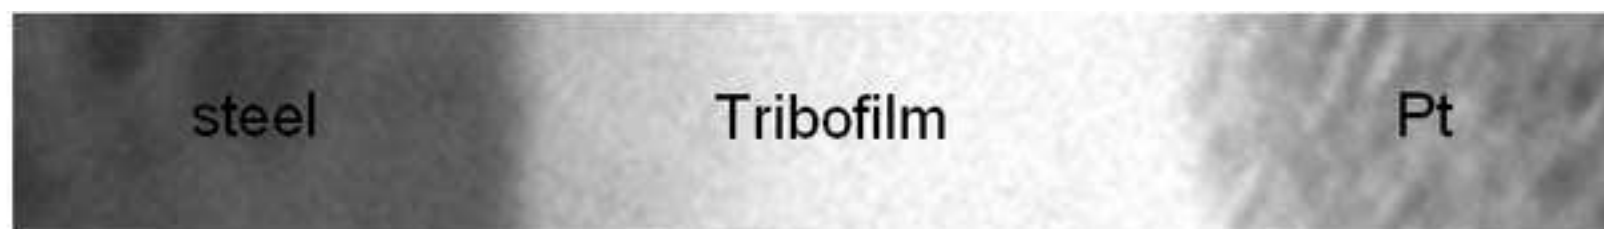
Fig8

- Fig.8 X-TEM micrograph and EDS line scan of wear scar H (hybrid composite slid against ground 100Cr6 disc at  $p_v=3 \text{ MPa} \cdot 1 \text{ m/s}$ )

the TEM/EDS investigation. Fig.8 shows the cross-section of a tribofilm corresponding to wear scar H formed at high pv conditions on a re-ground disc, thus providing the lowest level of silicone contamination, as proved in section 3.2. Here the appearance of the film corresponds to our expectations. The elemental profiles clearly reproduce the transitions from substrate to film and from film to the platinum cap layer. Film composition is homogeneous and consists mainly of Si and O with minor amounts of Fe and C. These results are consistent with RS suggesting the presence of carbonaceous material and iron oxide (see [3]).

Despite of the similarity of composition the structure of the two films shown in Fig.8 and 9 are completely different. Whereas the silicone film is an organic material, the silica-based tribofilm is of inorganic nature. This results in completely different tribological behaviours for conventional and hybrid composites, as will be shown later. In particular, the absence of the silicone fingerprint in Raman spectra taken from wear scars suggest, that silicone oil will degrade during tribological stressing. On the other hand, the stable silica-based films were only observed for wear scars produced by hybrid composites containing silica nanoparticles at

On the other hand, at the given stressing conditions ( $p_v=3 \text{ MPa} \cdot \text{m/s}$ ), friction and wear (the latter not shown here, but in [3]) of the two composites tested against steel discs is completely different. The beneficial tribofilm leading to the lower curve in Fig.11 corresponds to the one shown in Fig.8. This clearly demonstrates the advantage of the hybrid composite (H) compared to the conventional one (C). If the conventional composite is tested under the same conditions wear rates increase significantly and the originally formed carbonaceous tribofilm is destroyed. Simultaneously the COF increases up to a final value of 0.8, very similar to that
