Exploring the potential of Raman spectroscopy for the identification of silicone oil residue and wear scar characterization for the assessment of tribofilm functionality

Keywords: Raman spectroscopy,
Cross-sectional TEM,
Silicone oil residue,
Tribofilm

W.Österle^{a*}, A. Giovannozzi^b, T. Gradt^a, I. Häusler^a, A. Rossi^b, B. Wetzel^c, G. Zhang^{c, d}, A.I. Dmitriev^{e, f}

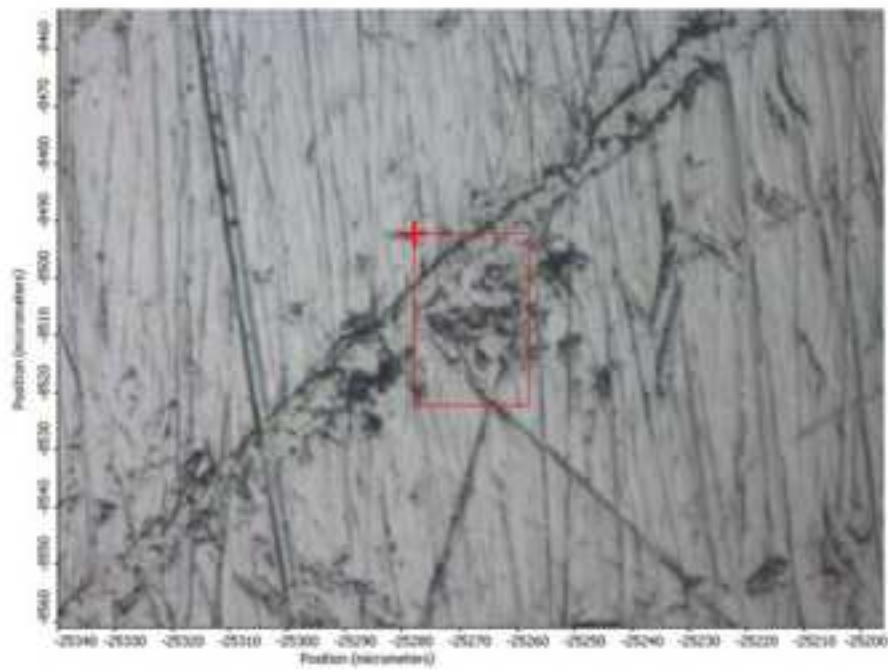
It should be mentioned that the intensity of the main silicone fingerprint is not uniformly distributed over the whole disc surface. Raman mapping can depict this. Fig.3 shows two examples of optical micrographs and their respective Raman maps produced by using

intensities obtained from windows around the major peak at 2900 cm^{-1} . Partly, the sites of higher silicone intensity correspond to features of the optical micrograph (e.g. groove-like features or roughness troughs, but this is not always the case. The dark blue areas of the Raman maps, visible in the web version of the article (major part of the maps, except bright spots with dark cores in the printed version) correspond to Raman spectra like the one shown in Fig.2c. Here definitely all silicone oil residues have been removed.

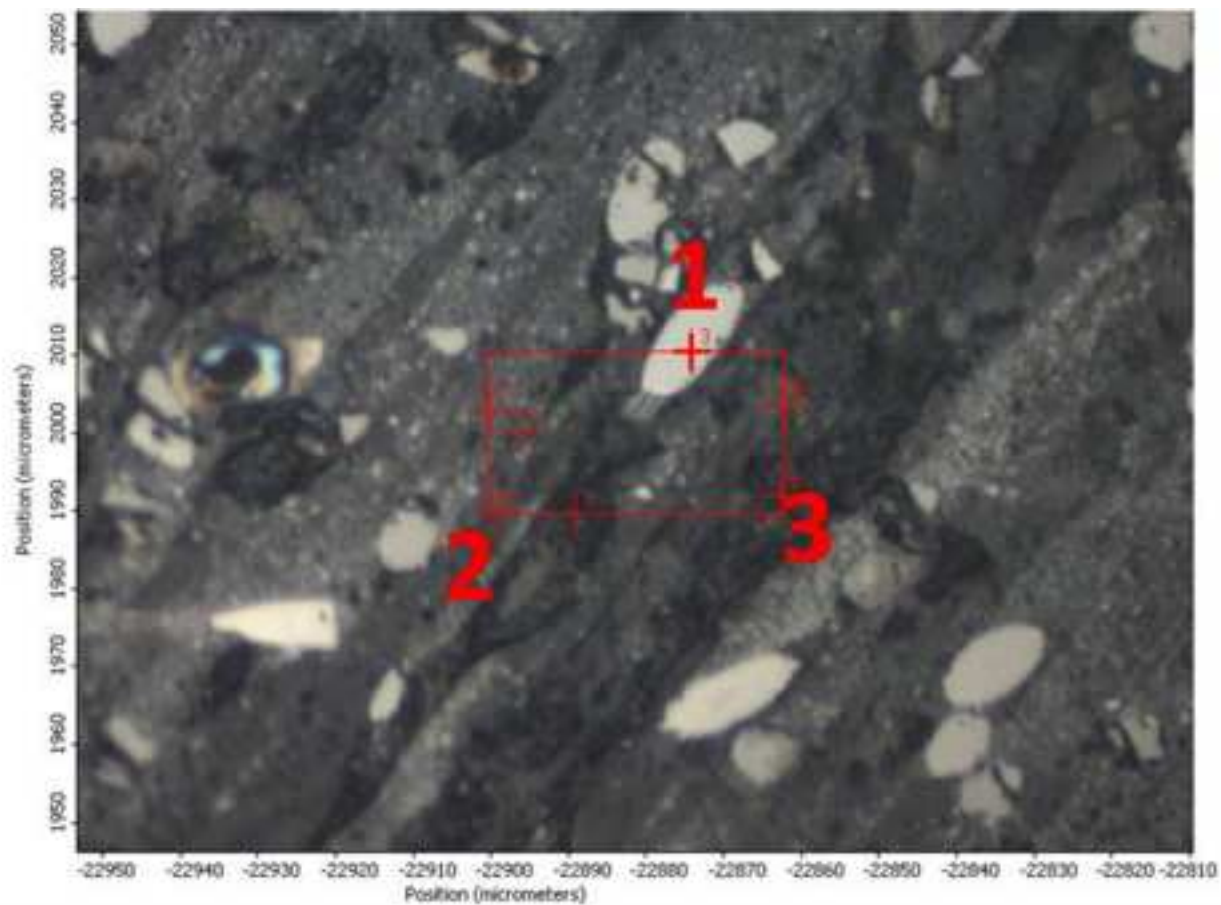
Fig.5 site 1 shows a typical spectrum of a carbon fibre. It shows only two major peaks, the D band at approximately 1350 cm^{-1} for disordered carbon, and the G band at 1580 cm^{-1} for graphitized carbon, in accordance with results from literature [29].

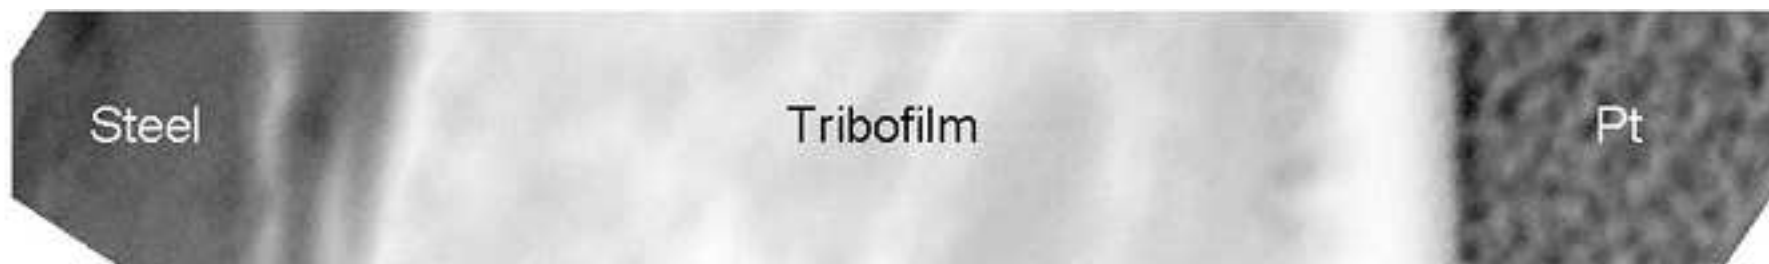
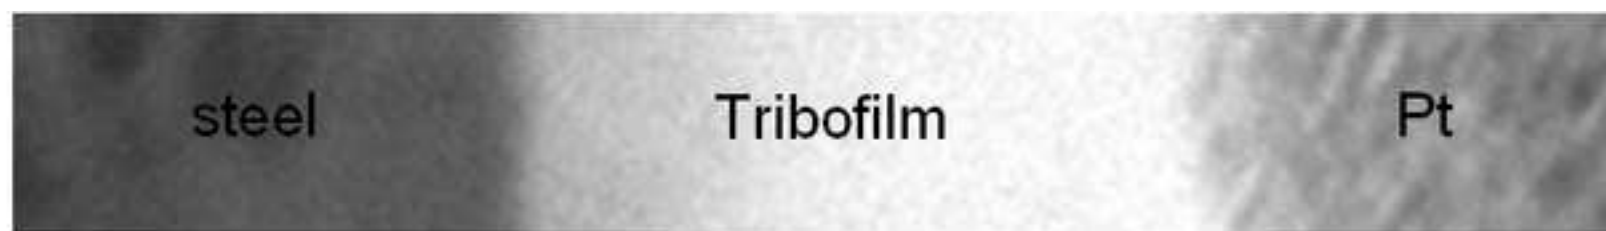
Figures 7a, 7b, 8 and 9 show the results of the X-TEM investigations for wear scars C and H, respectively. All films are more or less structureless i.e. amorphous, at least at the shown magnification. In high resolution TEM some tiny nanocrystals of iron oxide and graphite were observed previously [4], but not shown here. The EDS-results show significant differences not only between wear scars C and H, but also between different sites within the same wear scar. The film shown in Fig.7a consists mainly of carbon with minor amounts of iron and oxygen. It is likely that this corresponds to a film of transferred epoxy, which might develop because of the low p_v -value, or a carbonaceous product formed from epoxy mixed with iron oxide. The latter may form by tribooxidation of the disc surface. In contrast to site 1, the film observed at site 2 (Fig.7b) contains a considerable amount of Si and an increased amount of oxygen, while carbon is reduced compared to site 1. Since Si is not contained in the composite and only to a very small amount in the steel, we are quite sure that the high Silicon-concentration indicated in Fig.7b is due to silicone oil residue, locally identified on the disc surfaces despite of the cleaning procedures, as shown in section 3.2. A further feature apparent in Fig.7b is that the same high amount of Si revealed in the film is also detected in the adjacent steel substrate and platinum cap layer. This observation suggests a contamination of the TEM-specimen surface by a Si-containing species. A possible scenario for producing this feature could be that some silicone oil residue trapped in surface grooves evaporates during final FIB milling and re-deposits at the lamella surface. Thus, contamination of the TEM-specimens during preparation may explain the problems occurring occasionally during

- Fig.7 X-TEM micrographs and EDS-line scans at two different sites of wear scar C (conventional composite slid against acetone-cleaned 100Cr6 disc at $p_v=1 \text{ MPa}\cdot 1 \text{ m/s}$), a) site 1, b) site 2.
In b) the profile of O is always above the one of Pt, which is depicted clearly by color in the web version of the article.
