## Standard Paper

# An ecological investigation on lichens and other lithobionts colonizing rock art in Valle Camonica (UNESCO WHS n. 94) addresses preventive conservation strategies

Environmental control strategies are commonly practised to limit biodeterioration issues threatening indoor cultural heritage objects, while they are still poorly exploited for the conservation of outdoor stone heritage surfaces, including rock art. In this study, we evaluated the environmental factors driving the diversity and abundance of lithobiontic communities in the Rock Engravings National Park of Naquane (UNESCO WHS n. 94, Italy). The survey considered 23 rocks that had been cleaned in the last three (3YC) or twelve (12YC) years or more than 40 years ago (NRC). A cyanobacteria-dominated biofilm and lichens (37 taxa) were the most widespread and abundant lithobiontic components, prevailing on 3YC–12YC and NRC rocks, respectively. On the latter, a turnover of xerophytic and meso-hygrophytic lichen communities was observed. On 3YC–12YC rocks lichen colonization, if present, was limited to nitrophytic species, including common epiphytes from surrounding trees and a small number of meso-hygrophyti

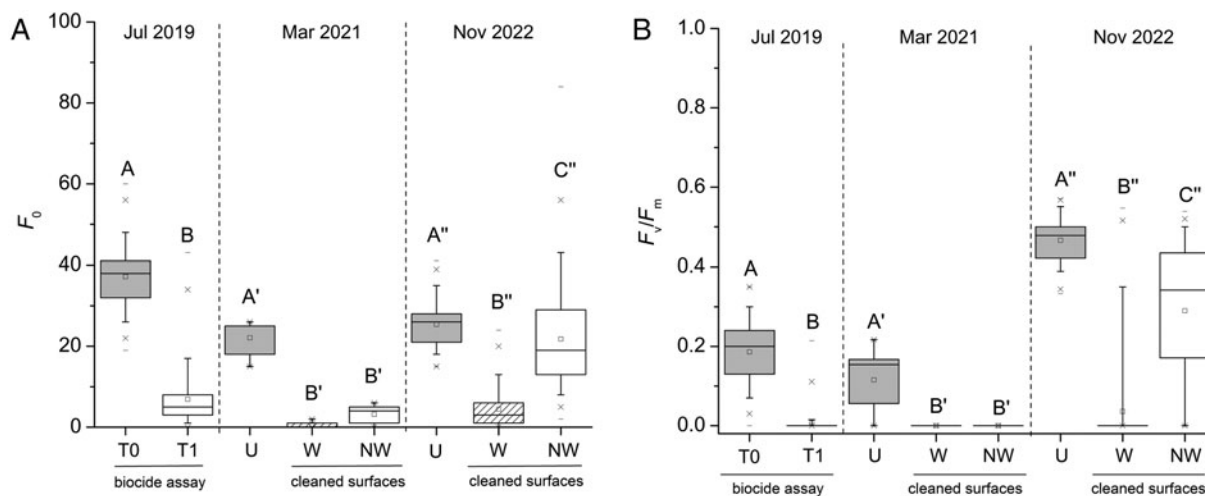
**Figure 5.** Basal fluorescence ( $F_0$ ; A) and maximum quantum efficiency of Photosystem II photochemistry ( $F_v/F_m$ ; B) quantified on Rock 70 during preliminary biocide assays (July 2019; T0 = one day before biocide application, T1 = one day after biocide application), and 20 (March 2021) and 40 (November 2022) months after the cleaning, in areas of the outcrop protected (W) and non-protected (NW) by the wall, and on uncleaned areas as control (U). Box-plots show 95<sup>th</sup> percentile (upper whisker), 75<sup>th</sup> percentile (top box), median (transversal line), mean (small square), 25<sup>th</sup> percentile (bottom box), 5<sup>th</sup> percentile (lower whisker). At each measuring time point, box-plots which do not share at least one letter are statistically different (ANOVA, Tukey's test,  $P < 0.05$ ).

Assays of the efficacy of Biotin T against lithobionts on Rock 70, and the cyanobacterial biofilm in particular, showed a significant decrease of  $F_0$  values in the treated parcels (decrease > 80%) with respect to measures performed before the biocide application, and the zeroing of  $F_v/F_m$  (Fig. 5A & B). Twenty months after the cleaning intervention, and after two winter seasons,  $F_0$  values quantified on the rock surface protected by the wall were zeroed, while slightly higher values were detected in the unprotected area, suggesting that recolonization was possibly starting. Accordingly, after 20 months more,  $F_0$  and

$F_v/F_m$  values quantified on the unprotected surface indicated the recovery of the lithobiontic colonization, while values were still zeroed in the area protected by the wall (with the exception of a single parcel, close to the ground at the foot of the rock). Lichen recolonization was not observed either in the protected or in the unprotected areas of Rock 70.
